Exploring the Effects of Contact Explosives on Concrete Columns

How high-speed imaging is enabling researchers to better understand the damage response of concrete columns subjected to contact explosives — research that has implications for the development of safer building implosion practices.

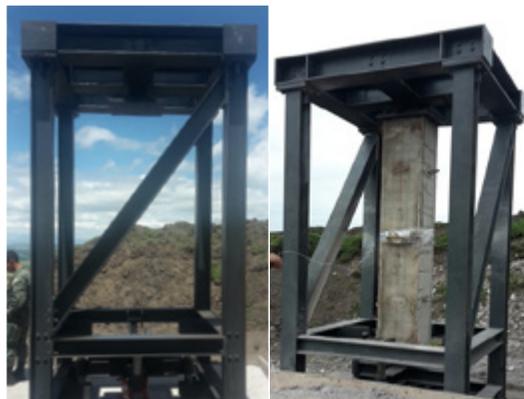
The structural frame, and the frame with a concrete column inside it.

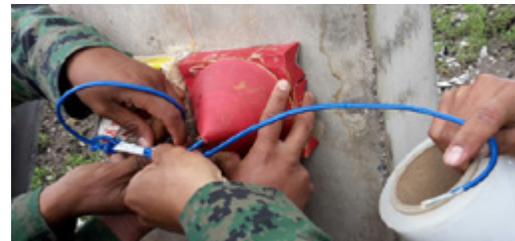
Attaching a conical-shaped explosive to the column.

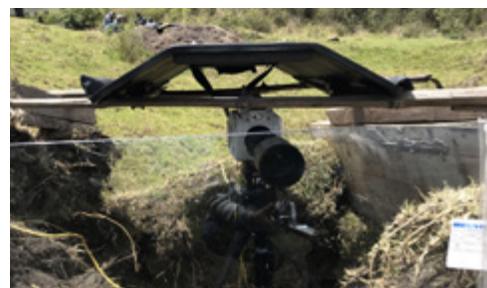
The Phantom v2512 high-speed camera, positioned 30 meters from the blast tests.

As part of his experimental trials, Meija used high-speed imaging equipment, a Phantom v2512 camera, which the team installed in a trench 30 meters away from the explosions. The camera was armored by bulletproof glass on the front side and an explosive orientation disposal (EOD) ballistics shield on the top side, protecting it from any concrete fragments from the blast waves.

Mejia adjusted the camera's field of view, resolution and focal length to maximize image quality. Specifically, the team set the recording speed to 75,000 frames per second (fps) and filmed the blast at 512 x 512 resolution with an exposure time of 13.33 microseconds (μ s).

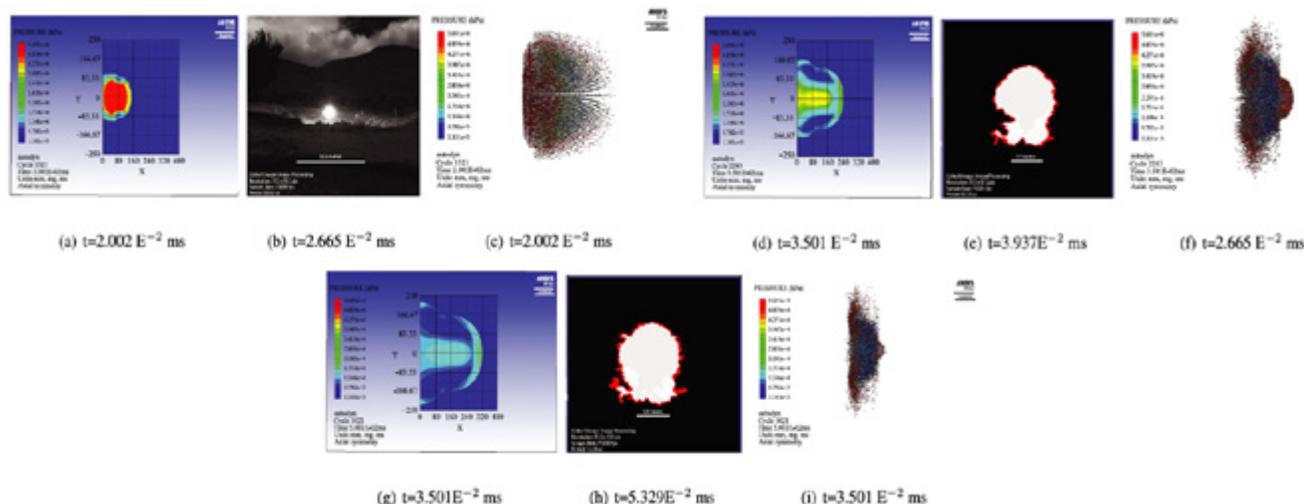
The numerical and experimental results for a conical charge of 150 grams of pentolite, demonstrating that the shock wave nonuniformly expands through the surrounding air. First, the shock wave adopts a vertical ellipse contour until 2×10^{-2} milliseconds (ms), after which it adopts a symmetric jellyfish dome-type profile.

Meija initially wanted to use high-speed Schlieren imaging to directly observe the damage sequence of the columns. “However, smoke and large dust clouds produced too much noise, blocking our target,” the researcher says. “The camera did capture the fireball, the expansion and compression of gas and the concrete fragmentation process, enabling us to observe the propagation of the shock wave. Using numerical calculations, we could then demonstrate that the blast nonuniformly expands through the surrounding air.”

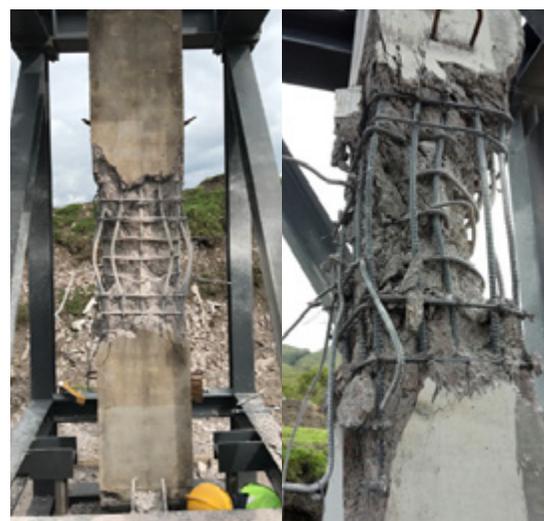
Concrete columns that have sustained moderate and extreme damage, respectively.

Based on their experimental and numerical studies, the University of the Armed Forces ESPE researchers found that RC columns subjected to contact explosions are damaged via a simultaneous supersonic shock wave and fireball, which cause concrete fragmentation in the following order:

1. The concrete cover is fragmented.
2. The transverse bars suffer shear.
3. The longitudinal bars buckle.
4. The concrete is partially or fully fragmented.

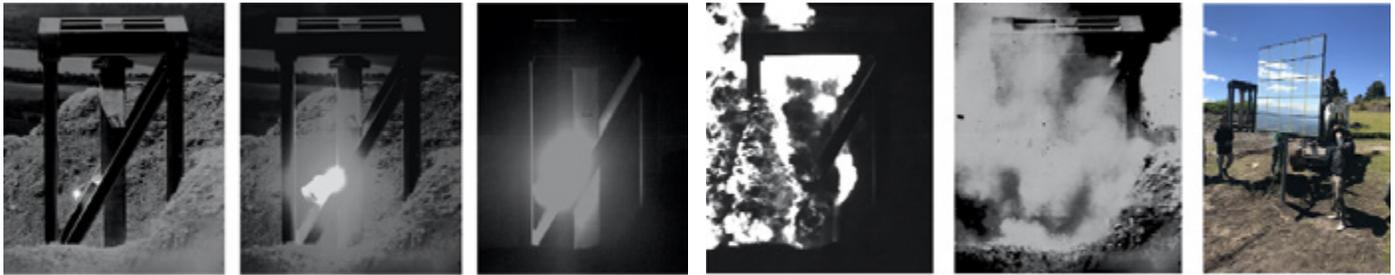
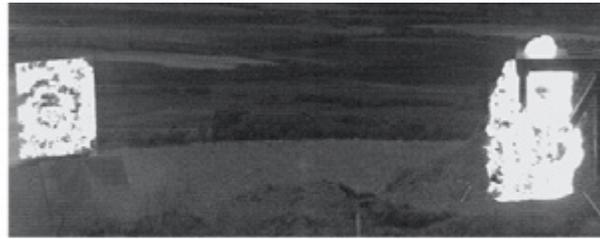
(a) Initiation

(b) Explosion

(c) Detonation

(d) Fire-ball

(e) Concrete fragments

(f) Mirrors

(g) Schlieren video

Results of the high-speed video taken using a Phantom v2512 recording at 75,000 fps at 512 x 512 resolution. Exposure time: 13.33 microseconds. Focal length: 32.41 millimeters.
